Volume V

Appendix G.12

Crew Survivability

Crew Survivability Report

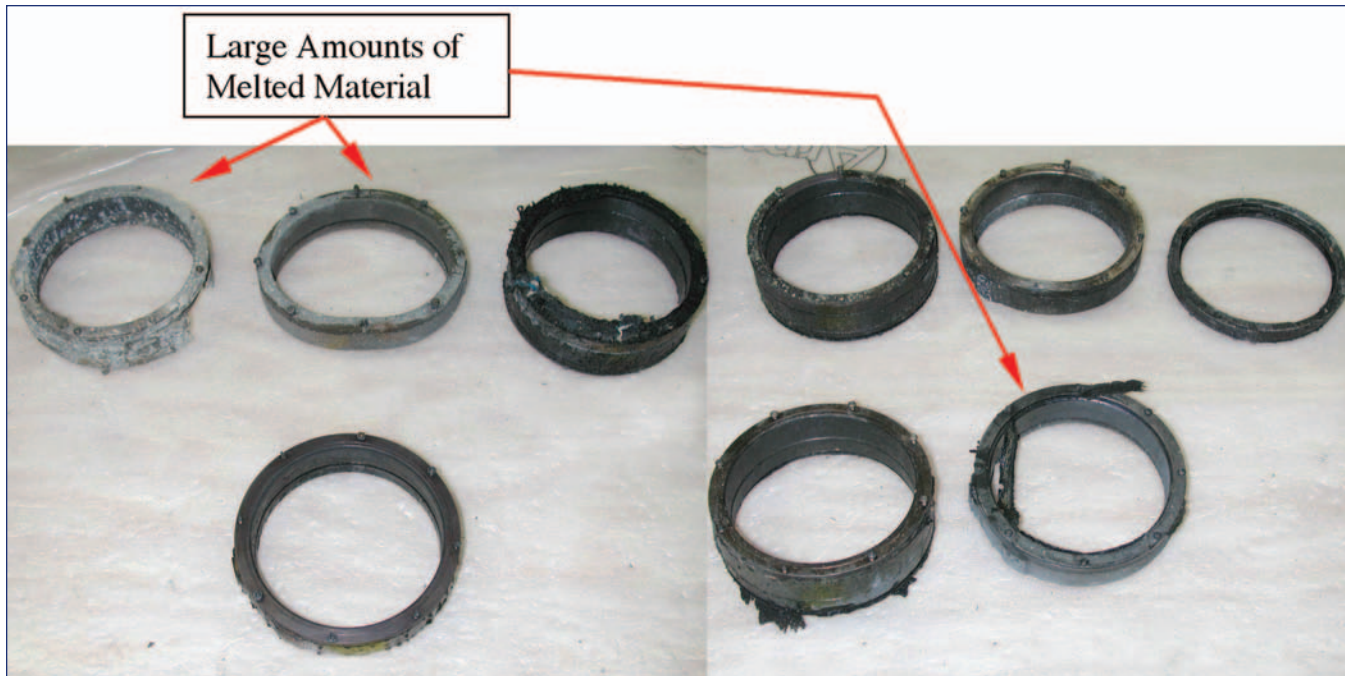
Recovered Glove Disconnects.

corresponding to six out of seven crewmembers. Exposure to entry heating environments is apparent throughout. However, the level of heating varied substantially from item to item. Items from some crewmembers experienced significantly greater heating than comparable items on other crewmembers. Also, significant differences in heating were noted from the left to right sides on some crewmembers equipment. Detailed inspection of recovered debris items suggests that three of the seven crewmembers did not have gloves properly installed during re-entry.

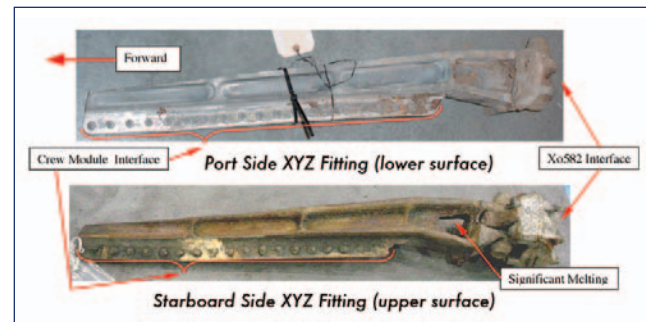
Both the port and starboard side XYZ fittings were recovered intact with evidence of high heating. Both titanium fittings experienced significant thermal exposure / melting, predominantly on the upper surfaces. In comparison, the starboard side fitting experienced significantly greater heating than the port side.

Each fitting exhibited failures at both its crew module interface and Xo582 frame interface. The crew module interface failed at the longeron tab on both the port and starboard sides. Fasteners along the joint remained intact. On the Xo582 frame interface, the port side experienced a lug tensile failure while the starboard side fittings pulled through the Xo582 frame.

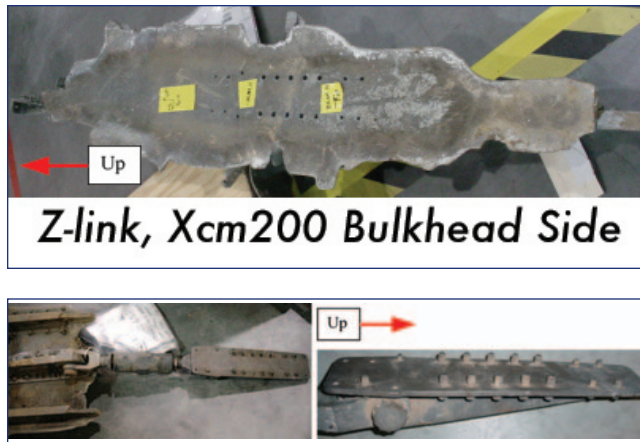
Both the port and starboard side Xo576 interfaces of the double strut Y-link assembly were recovered (the Xo582 side interface was not recovered). Both the port and starboard side struts of the Y-linkage failed in tension at the clevis end fittings. The port side failed in proximity to the Xo582 ring frame, the starboard side in proximity to the Xo576 bulkhead.

The Z-link failed at the attach point to the Xcm200 bulkhead. The joint failed by a combination of both fastener tensile failure and fastener insert pullout

Detailed inspection of each linkage failure suggests the failure mode was affected by a reduction in material properties associated with elevated temperatures.

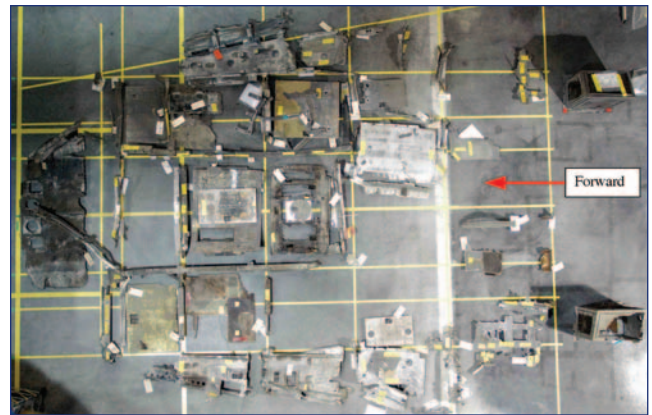
Mid Deck Floor Debris (looking down).

The only recovered mid deck floor item which experienced significant re-entry heating was the LiOH door floor panel, with the corresponding seat 6 and 7 attachments. The panel itself was highly melted, with thin sections completely missing. Detailed inspection of heat patterns suggest that directional heating occurred along a flow vector directed “bottom-up.” The mid deck seat 6 and 7 locations collected

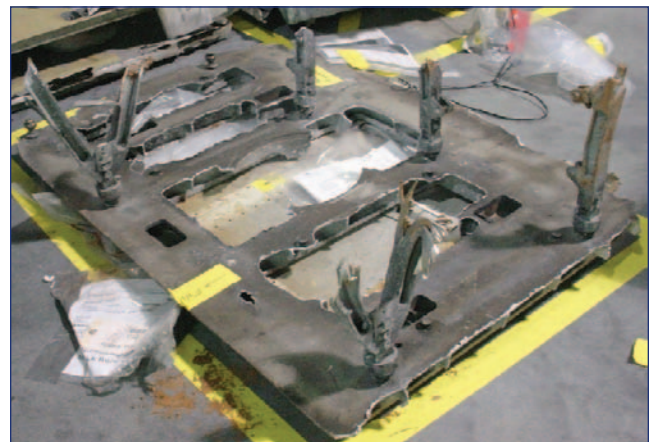
LiOH Door Floor Panel With Seat 6 & 7 Attach Points.

deposits of melted aluminum consistent with the mid-deck floor panel they were attached to (verified by materials analysis and consistent with the flow direction). Materials

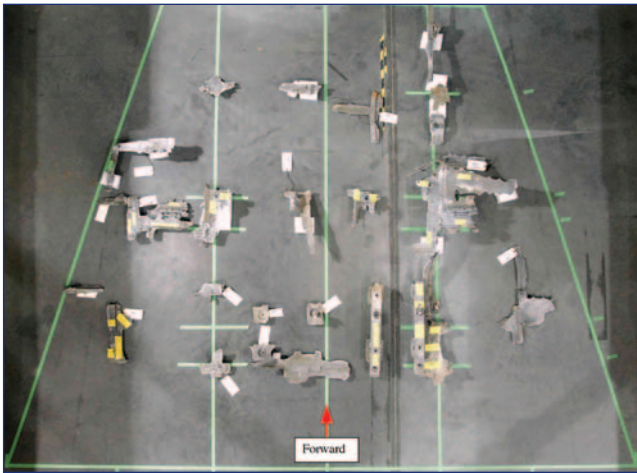
Flight Deck Floor Debris (looking down).

Unlike the mid deck floor, it is estimated that less than 10% of the flight deck floor was recovered. This is attributed to the substantial amount of heating experienced in this area.

Generally, only small portions of flight deck floor panels, structure, and seat components were recovered. In all cases, debris components are highly melted and/or deposited with splattered aluminum on all surfaces. None of the coating materials (topcoat or primer) survived.

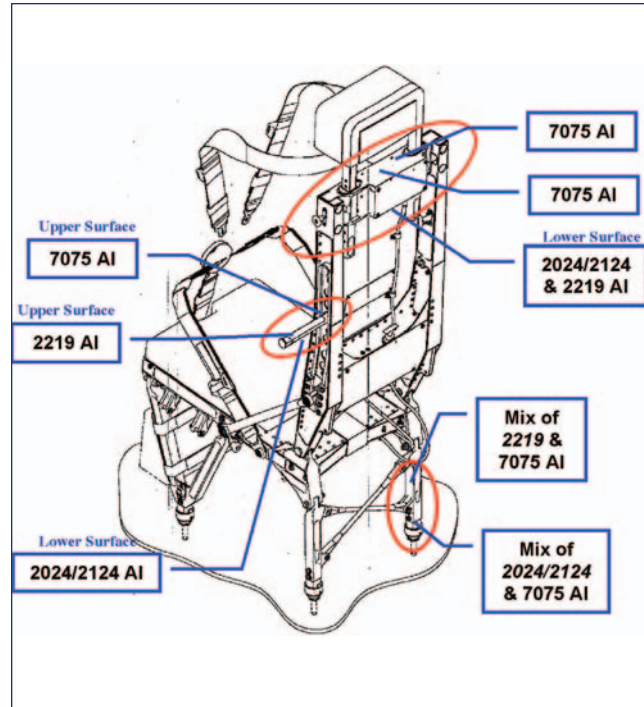
Flight Deck: Materials Sampling Analysis on Recovered Seat Debris Items.

The flight deck seat locations collected substantial deposits of melted aluminum from locations throughout the cabin area (verified by materials analysis). Materials consistent with the bulkheads and outer pressure shell (2219 aluminum), the surrounding primary and secondary structure (2219, 2024, 2124, and 7075 aluminum), and the seat itself (2024 and 7075 aluminum) were discovered on both upper and lower surfaces of recovered seat debris. See below for a description of findings:

Thus, the flight deck seats remained attached to both flight deck floor panels and surrounding structure during thermal exposure.

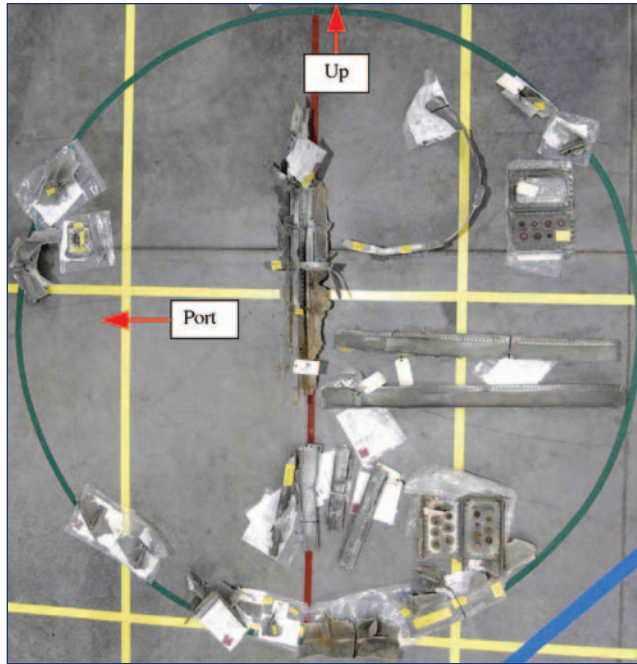
Forward Bulkhead Debris (looking forward).

Further Analysis of the forward bulkhead structural failure is still in work.

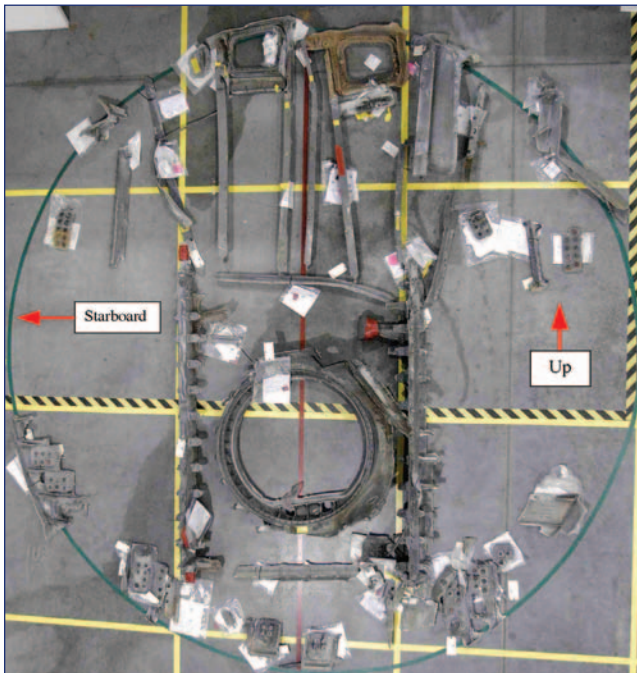
Aft Bulkhead Debris (looking aft).

The failure mode of the aft bulkhead structure has not been determined. Debris items recovered from the aft bulkhead show heating patterns initiating from multiple directions. All of the recovered stiffeners appear to have sheared along their attach points, consistent with a bulkhead bending failure. Some failure modes appear to have been affected by elevated temperatures.

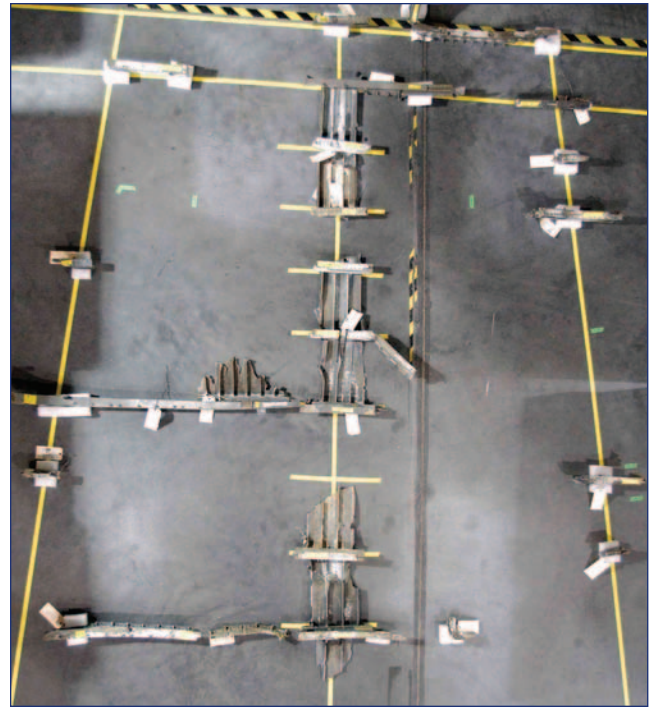
Lower Crew Module Pressure Shell Debris.

Barely ANY of the exterior pressure shell was recovered. Apparently, re-entry heating was sufficient to burn / melt away nearly all exposed thin sections (including bulkhead areas). In general, the only pieces of the pressure shell remaining were found attached to corresponding structure. Relatively speaking, more of the pressure shell was recovered from the lower crew module area than anywhere else .

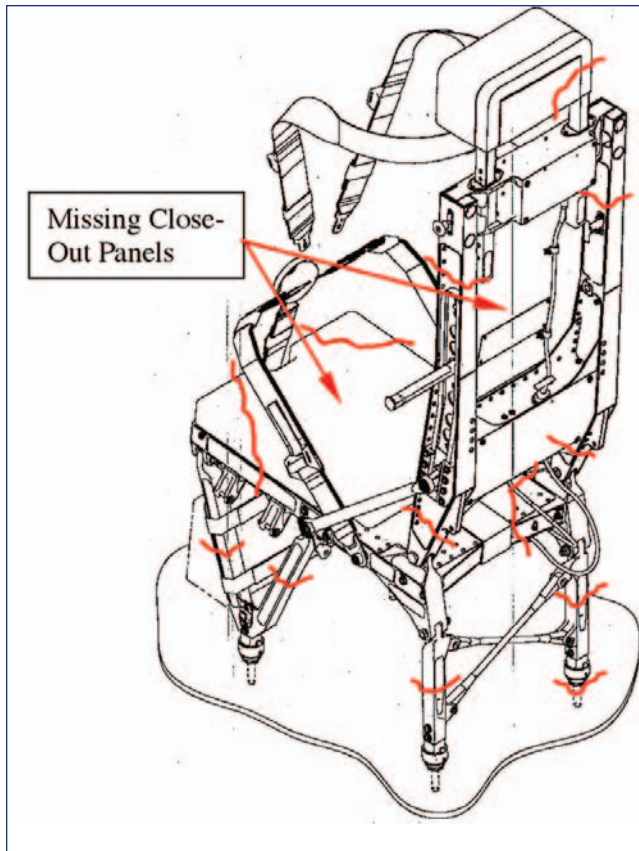
In nearly all cases, seat components generally fractured into relatively small pieces. It is noted that nearly all seat component fractures occurred at minimum thermal cross-sectional areas (minimum thermal mass), away from any large heat sink locations. It is also noted that nearly all thin-sheet aluminum materials (close-out panels on seat pan and seat back) are completely missing (i.e. overloaded / melted away). Common seat component fracture locations are shown below:

Common Seat Failure Locations (shown in red)
(NOTE: Mission Specialist seat shown; Components below seat pan on Commander/Pilot seat are different in design).

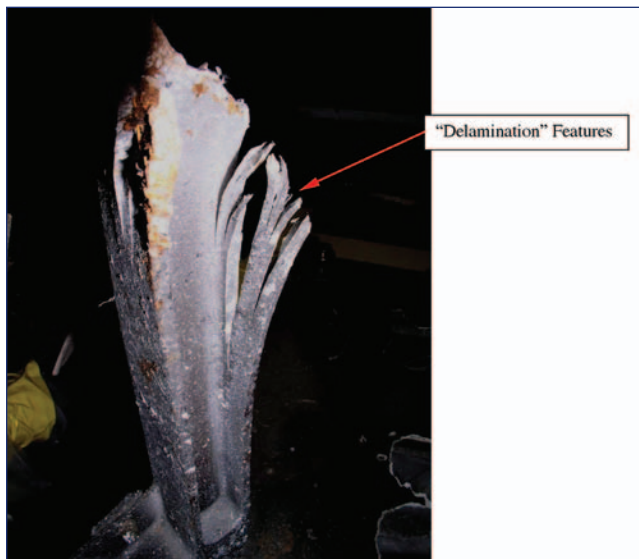
Example of “Broom-Straw” Fracture.

Upon inspection of fracture surfaces, a very unique “delamination” type fracture pattern was identified that is consistent throughout the seat component debris items. Several fractures almost appear as if the 7075 aluminum material is constructed of a laminate material (see below) when in ac-

tual fact the material is solid aluminum plate not a laminate structure. This phenomenon was termed as “broom-straw” fractures (see Example below).

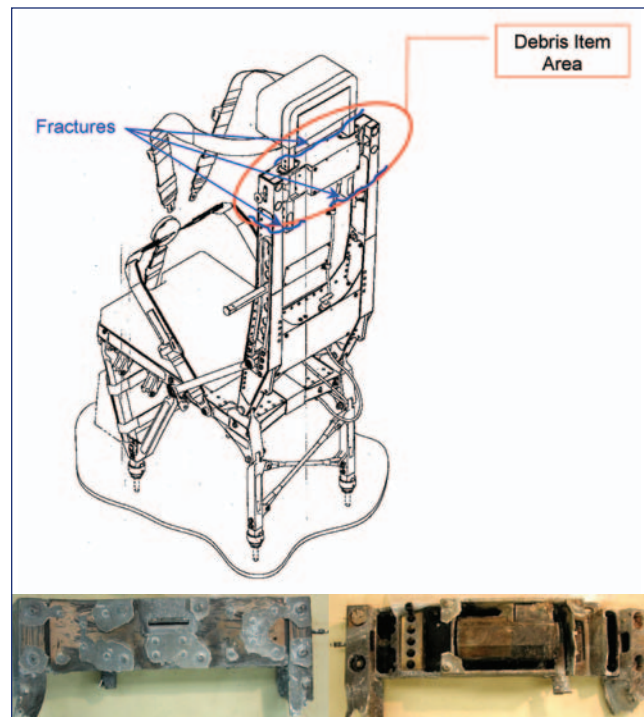
Schematic of “Upper Seat Back” Debris Location, and Example of Representative Debris Item (front and back shown).

Six out of seven “Upper Seat Back” debris items were recovered (all but Seat 5). Each item was positively identified to a seat position. Each recovered upper seat back debris item contains the upper seat strap recoil mechanism and some amount of strap material, which had recoiled back into the mechanism subsequent to strap failure. A description of the debris location and an example of one recovered upper seat back debris item follows:

In all cases, fractures at the upper seat back location occurred at the minimum thermal cross section, away from heat sinks on either side. These fractures are consistent with the general seat failure mechanism (thermal heating followed by mechanical overload).

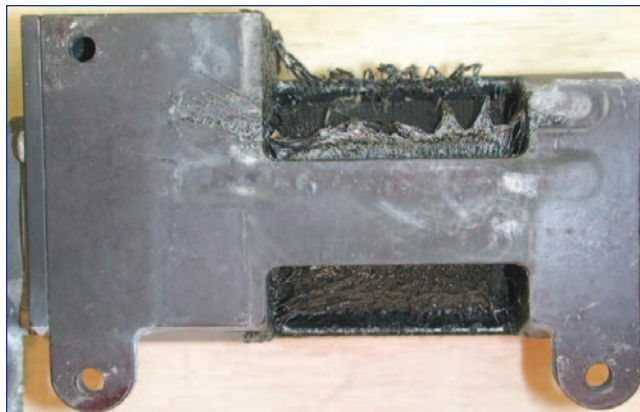
In all cases, a significant amount of melted / splattered strap material was discovered internal to the upper back seat cavity. Melting appears associated with air flow entering the upper seat back strap entry point. Melt patterns suggest melting occurred AFTER the seat straps had been recoiled into the housing (i.e. post-failure). Thus, it can be concluded that crewmembers were removed prior to completion of thermal heating event.

Example of Strap Melt Patterns Surrounding Recoil Mechanism.

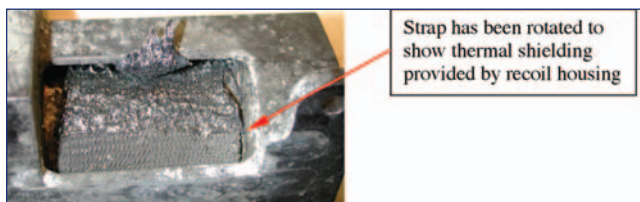
Close-Up of Strap Melt Patterns.

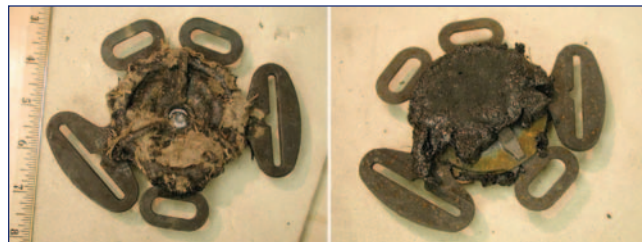
Recovered 5-Point Seat Belt Buckle (front and back shown).

Only one of seven 5-point seat belt buckles was recovered. Positive identification was not possible. The one recovered buckle experienced significant re-entry heating. This resulted in substantial melting of the outer plastic housing. The structure however remained intact, with all five clasps still in place.

Surprisingly, the two upper strap attach clasps were bent *outward* (away from the crewmember). All other clasps appeared nominal. The buckle assembly was disassembled in an attempt to locate "witness marks" which may have been caused by mechanical loading. Nothing was found.
